USE OF REINFORCED EARTH® FOR CONSTRUCTION OF THE SM RAMP ON THE SPRAIN BROOK PARKWAY

BERNARD E. BUTLER, P. E.

Associate Soils Engineer
New York State Department of Transportation
Soil Mechanics Bureau

This paper was presented in December, 1980 at a geotechnical seminar on Earth Support Systems sponsored by the New York City Metropolitan Section of the American Society of Civil Engineers (ASCE). It has been excerpted and reprinted with the author's permission. Publication of this paper does not constitute endorsement of The Reinforced Earth Company by the author or by the New York State Department of Transportation.

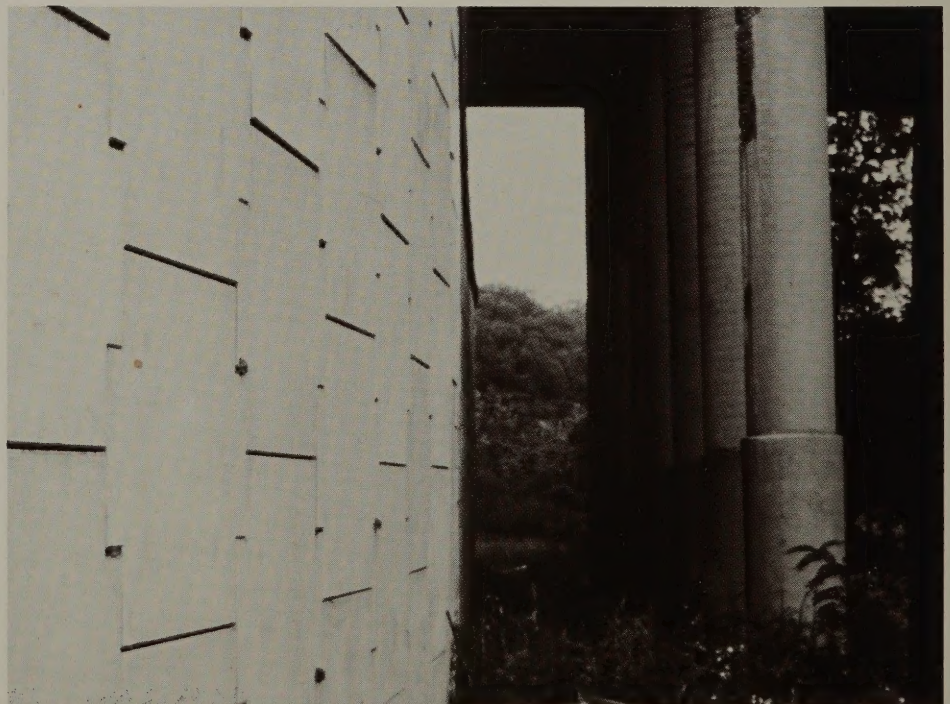
Figure 4. East wall of SM ramp.

Two other alternatives were considered: build this ramp as a viaduct structure or, use Reinforced Earth to form a box cross-section about 40 ft wide. The use of vertical walls would move the ramp load further from the piers, decreasing the drag force to an estimated 10 tons per pile (See Figures 3 and 4).

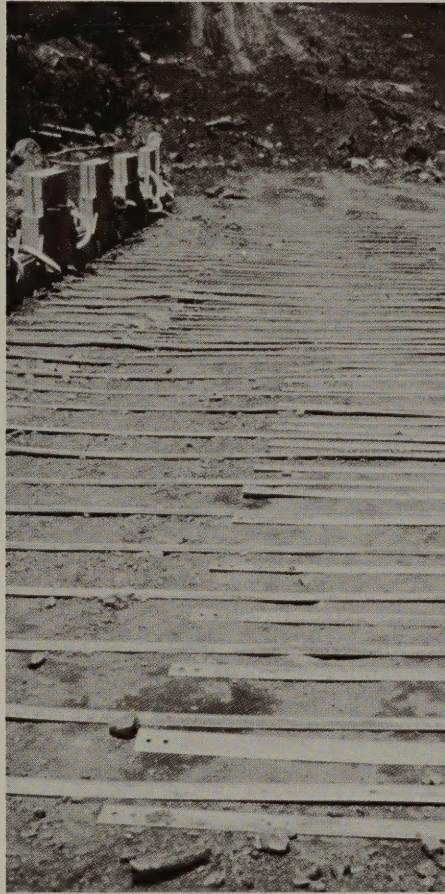
Figure 5. Placement of reinforcing strips extending from east and west walls.

The ramp extending from the abutment would be supported on each side by a Reinforced Earth wall for most of its length. The reinforcing strips for each of the parallel walls would be placed in a staggered pattern to avoid strip interference. The walls would be independent structures, not tied together. This was accomplished as shown in Figure 5.

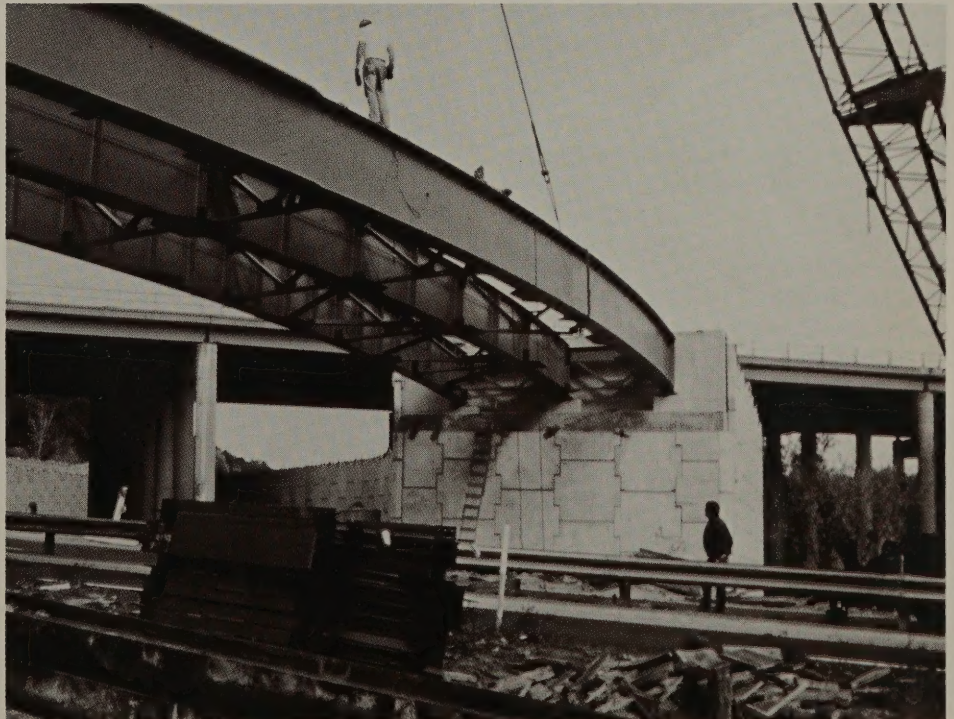
Figure 6. Reinforced Earth retaining wall at the north end of the structure above the Saw Mill River Parkway.

Analyses at the abutment site indicated that steel H-piles, driven to refusal, would be required to prevent settlement at the end of the two-span curved, continuous structure over the Saw Mill River Parkway (See Figure 6). About three inches of settlement was expected at this location due to the embankment load. The piles would be driven before beginning Reinforced Earth construction to avoid striking the reinforcing strips.

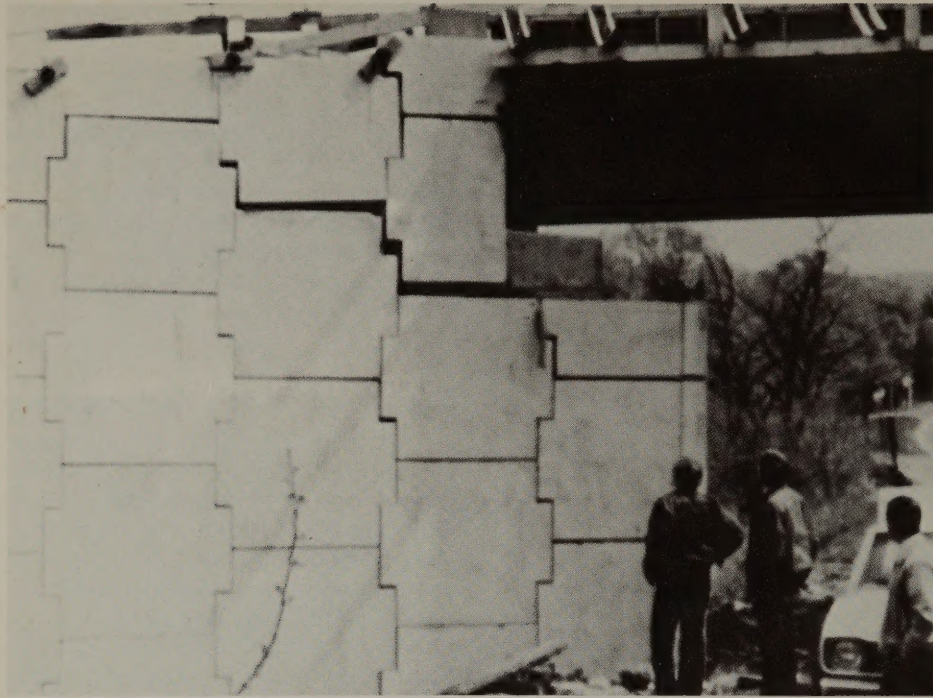
Figure 7. Settlement gaps resulting from incorrect attachment of reinforcements to the bridge seat supported on piles.

For example, the reinforcing strips of the "cheek" panels at the north abutment were supposed to be clear and independent of the abutment itself. However, the top panels on the west side of this pile-supported abutment were unintentionally anchored into the

abutment and, therefore, were restrained from settling as the foundation soils consolidated (See Figure 7). This situation was easily corrected by detaching the panels where necessary and refastening them once settlement was complete.

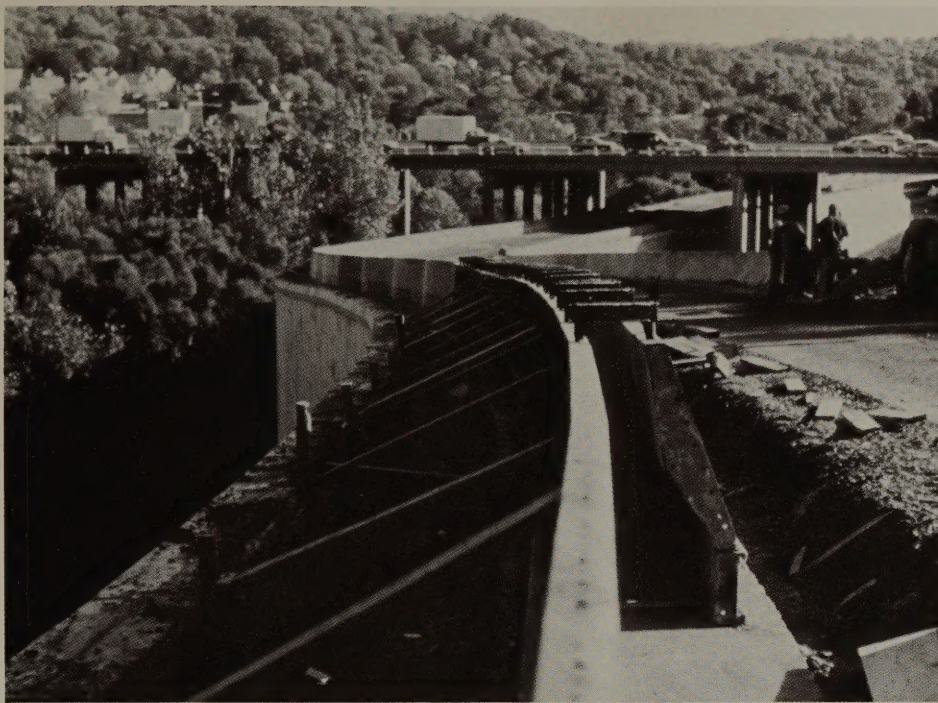
Figure 10. Barrier construction.

The plan for determining dimensions of topping-off panels was not implemented because settlement continued beyond the two-week waiting period. A modified top section was accepted to eliminate the need for more panels. The new design used Jersey Barriers

just beyond the edge of pavement where guard rails were originally specified. Granular fill material was placed outside the barriers and sloped down to the top of the Reinforced Earth walls. Construction of the modified top sections is shown in Figure 10.
